**Flood Control Project Maintenance
Levee Inspections**
LMA District Cover Sheet
Spring 2017 Levee Inspection Results

Reclamation District No. 0150 Merrit Island

Spring 2017 Levee Inspection Results

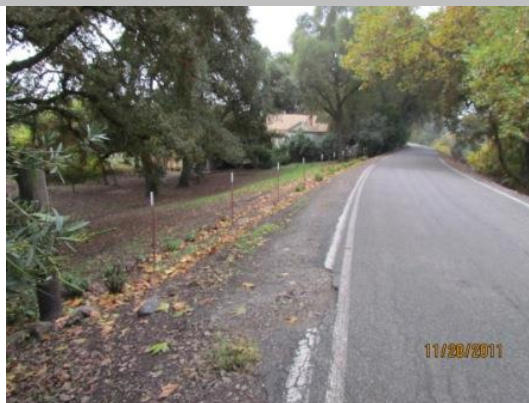
Photo 1 of 1 : SP_2017_RD0150_17_13_20170327_00007.jpg

LM Start	6.82	Rating **	M	Issue No.	13
LM End	6.93	Issue Type +	En	Location *	LS
Category	Earthen Levee			GPS Latitude/Longitude	
				Start	End
Item	Encroachments			38.395998 °	38.395470 °
				-121.536613 °	°
DWR ID	DWR_RD0150_03_s_2012_13				
Comment Code					
FE : Fence					
Inspector Comment

Fence was found on the landside of the levee looking downstream.

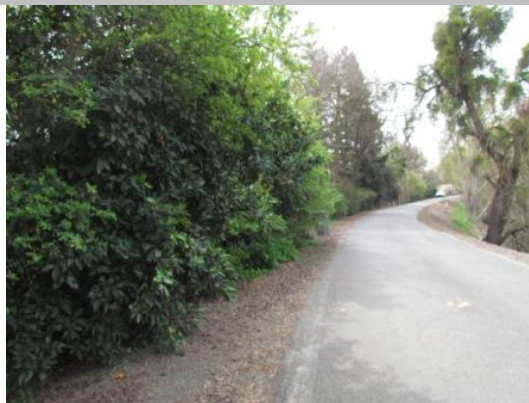
Photo 1 of 1 : SP_2017_RD0150_17_933_20170327_00085.jpg

LM Start	6.85	Rating **	U	Issue No.	933
LM End	6.93	Issue Type +	En	Location *	LS
Category	Earthen Levee			GPS Latitude/Longitude	
				Start	End
Item	Vegetation			38.396187 °	38.396989 °
				-121.536180 °	-121.535151 °
DWR ID	DWR_RD0150_03_s_2012_933				
Comment Code					
V6 : Landscaping					
Inspector Comment					
Landscaping has been maintained better, but some obstructions still exist.

View of the landscape on the landside shoulder of the levee looking downstream.

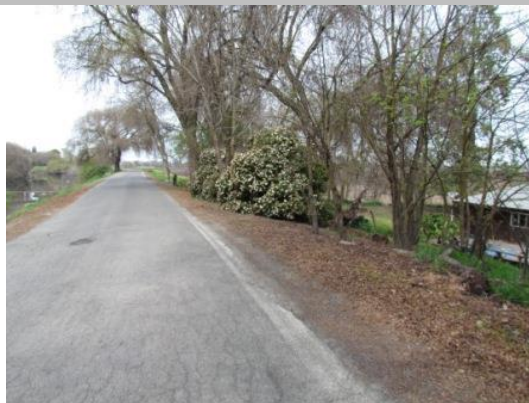
Photo 1 of 1 : SP_2017_RD0150_17_31_20170327_00017.jpg

LM Start	6.93	Rating **	M	Issue No.	31
LM End	6.97	Issue Type +	En	Location *	LS
Category	Earthen Levee			GPS Latitude/Longitude	
				Start	End
Item	Vegetation			38.397021 °	38.397540 °
				-121.535151 °	-121.535183 °
DWR ID	DWR_RD0150_03_s_2012_31				
Comment Code					
V6 : Landscaping					
Inspector Comment

Landscaping was found on the landside shoulder of the levee looking upstream.

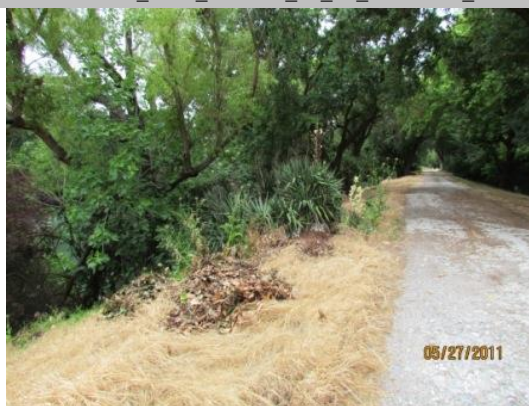
Photo 1 of 1 : SP_2017_RD0150_17_64_20170327_00045.jpg

LM Start	7.26	Rating **	U	Issue No.	64
LM End	7.26	Issue Type +	En	Location *	WS
Category	Earthen Levee			GPS Latitude/Longitude	
				Start	End
Item	Vegetation			38.401481 °	38.401481 °
				-121.536876 °	-121.536876 °
DWR ID	DWR_RD0150_03_s_2012_64				
Comment Code					
V6 : Landscaping					
Inspector Comment

Landscaping on the waterside of the levee. The picture was taken from the crown looking upstream.

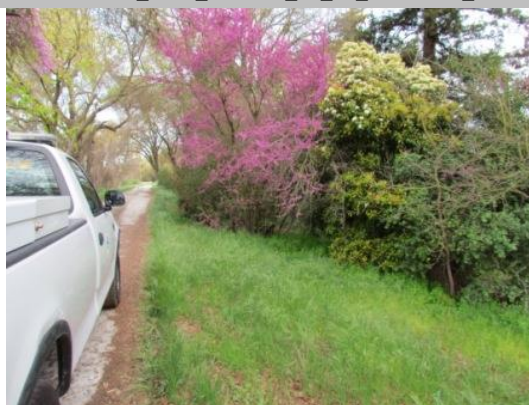
Photo 1 of 2 : SP_2017_RD0150_17_32_20170327_00018.jpg

LM Start	7.29	Rating **	U	Issue No.	32
LM End	7.34	Issue Type +	En	Location *	LS
Category	Earthen Levee			GPS Latitude/Longitude	
				Start	End
Item	Vegetation			38.401738 °	38.402296 °
				-121.537127 °	-121.537678 °
DWR ID	DWR_RD0150_03_s_2012_32				
Comment Code					
V6 : Landscaping					
Inspector Comment

Vegetation on the landside of the levee looking upstream. This picture was taken during spring 2012 inspection.

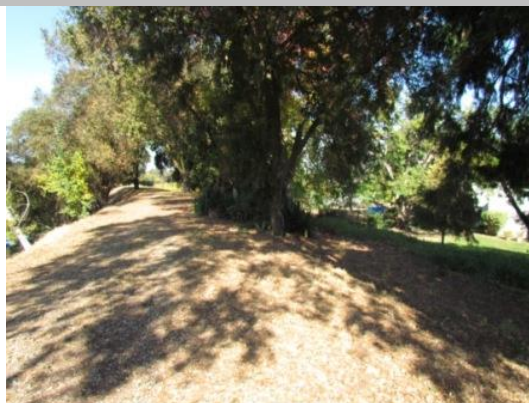
Photo 1 of 1 : SP_2017_RD0150_17_84_20170327_00064.jpg

LM Start	7.40	Rating **	M	Issue No.	84
LM End	7.40	Issue Type +	En	Location *	LS
Category	Earthen Levee			GPS Latitude/Longitude	
				Start	End
Item	Vegetation			38.403047 °	38.403047 °
				-121.538433 °	-121.538433 °
DWR ID	DWR_RD0150_03_s_2012_84				
Comment Code					
V6 : Landscaping					
Inspector Comment

Landscaping was found on the landside shoulder of the levee looking upstream.

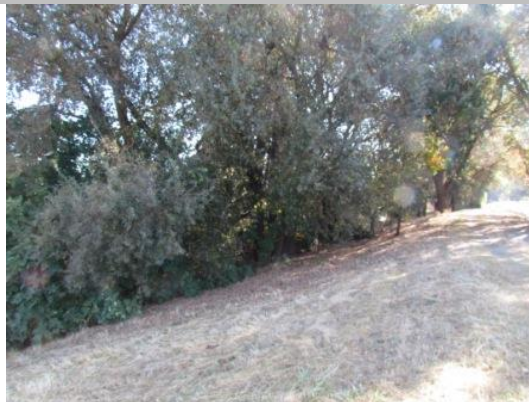
Photo 1 of 1 : SP_2017_RD0150_17_934_20170327_00086.jpg

LM Start	7.44	Rating **	U	Issue No.	934
LM End	7.44	Issue Type +	En	Location *	LS
Category	Earthen Levee			GPS Latitude/Longitude	
				Start	End
Item	Vegetation			38.403566 °	38.403566 °
				-121.538886 °	-121.538886 °
DWR ID	DWR_RD0150_03_s_2012_934				
Comment Code					
V6 : Landscaping					
Inspector Comment

Landscaping was blocking the visibility on the landside of the levee looking downstream.

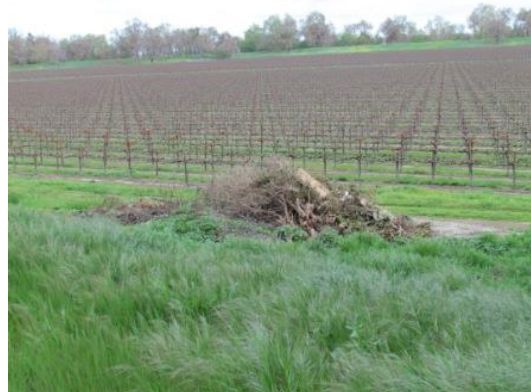
Photo 1 of 2 : SP_2017_RD0150_17_935_20170327_00087.jpg

LM Start	7.47	Rating **	M	Issue No.	935
LM End	7.47	Issue Type +	En	Location *	LS
Category	Earthen Levee			GPS Latitude/Longitude	
				Start	End
Item	Encroachments			38.403795 °	38.403795 °
				-121.539205 °	-121.539205 °
DWR ID	DWR_RD0150_03_s_2012_935				
Comment Code					
PR : Prunings					
Inspector Comment

Prunings were found on the landside of the levee looking upstream.

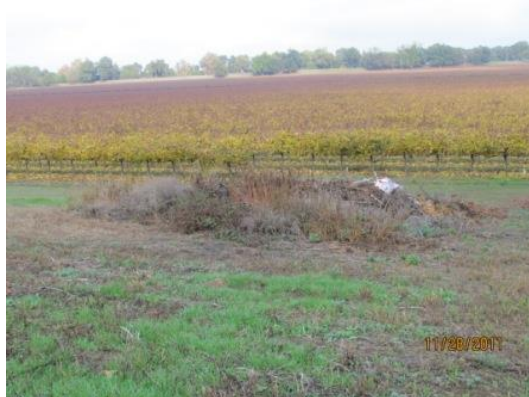
Photo 2 of 2 : SP_2017_RD0150_17_935_20170327_00088.jpg

LM Start	7.47	Rating **	M	Issue No.	935 (cont)	
LM End	7.47	Issue Type +	En	Location *	LS	
Category	Earthen Levee			GPS Latitude/Longitude		
				Start		End
Item	Encroachments			38.403795 °	38.403795 °	
				-121.539205 °	-121.539205 °	
DWR ID	DWR_RD0150_03_s_2012_935					
Comment Code						
PR : Prunings						
Inspector Comment

Prunings were found on the landside of the levee looking upstream. This picture was taken during fall 2011 inspection.

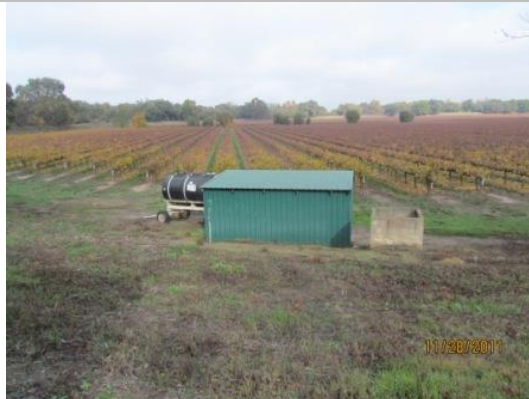
Photo 1 of 1 : SP_2017_RD0150_17_16_20170327_00008.jpg

LM Start	7.68	Rating **	M	Issue No.	16
LM End	7.68	Issue Type +	En	Location *	LS
Category	Earthen Levee			GPS Latitude/Longitude	
				Start	End
Item	Encroachments			38.405342 °	38.405342 °
				-121.542553 °	-121.542553 °
DWR ID	DWR_RD0150_03_s_2012_16				
Comment Code					
BU : Building					
Inspector Comment

Equipment and buiding was found on the landside of the levee looking upstream.

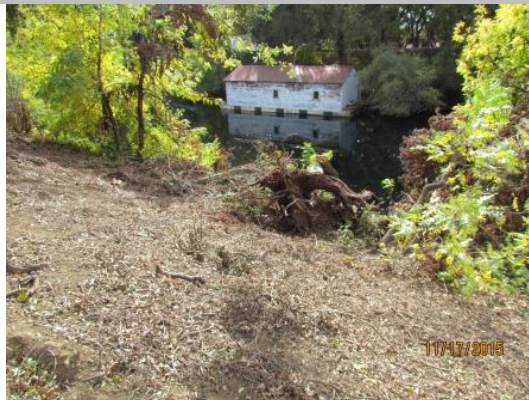
Photo 1 of 1 : SP_2017_RD0150_17_52_20170327_00034.jpg

LM Start	7.70	Rating **	M	Issue No.	52
LM End	7.70	Issue Type +	Ma	Location *	WS
Category	Earthen Levee			GPS Latitude/Longitude	
				Start	End
Item	Encroachments			38.405536 °	38.405536 °
				-121.542752 °	-121.542752 °
DWR ID	DWR_RD0150_03_f_2015_52				
Comment Code					
TR : Tree or limb					
Inspector Comment					
Tree trunks and stumps might damage the levee toe during high water.

View of the tree trunk on the waterside toe of the levee.

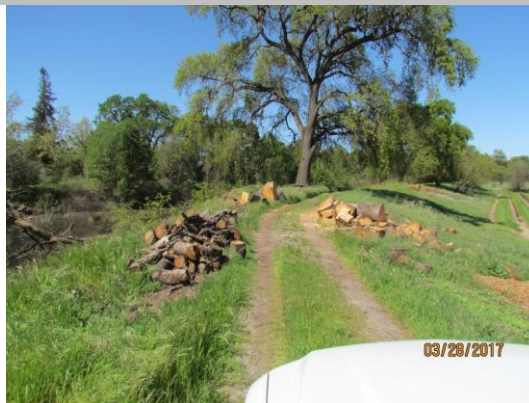
Photo 1 of 1 : SP_2017_RD0150_17_112_20170330_00152.jpg

LM Start	7.73	Rating **	M	Issue No.	112
LM End	7.73	Issue Type +	En	Location *	WS
Category	Earthen Levee			GPS Latitude/Longitude	
				Start	End
Item	Encroachments			38.405949 °	38.405949 °
				-121.542996 °	-121.542996 °
DWR ID	DWR_RD0150_03_s_2017_112				
Comment Code					
FW : Firewood					
Inspector Comment

View of firewoods on the waterside shoulder of the levee looking upstream.

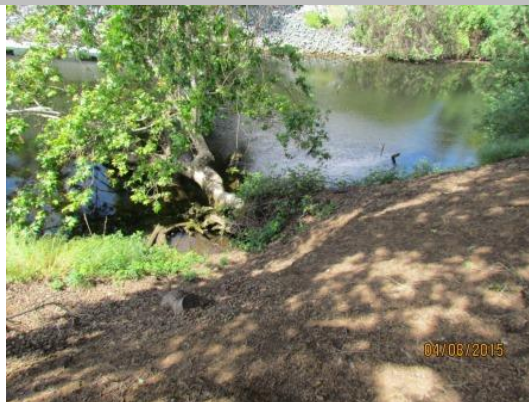
Photo 1 of 1 : SP_2017_RD0150_17_396_20170327_00084.jpg

LM Start	7.74	Rating **	M	Issue No.	396
LM End	7.74	Issue Type +	Ma	Location *	WS
Category	Earthen Levee			GPS Latitude/Longitude	
				Start	End
Item	Slope Stability			38.406098 °	38.406098 °
				-121.543028 °	-121.543028 °
DWR ID	DWR_RD0150_03_s_2015_396				
Comment Code					
S1 : Repair slope instability.					
Inspector Comment					
Slope instability caused by a tree.

Slope instability was found on the waterside toe of the levee looking upstream.

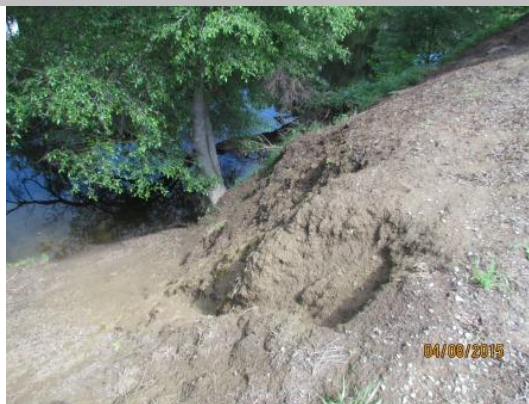
Photo 1 of 2 : SP_2017_RD0150_17_92_20170327_00070.jpg

LM Start	8.02	Rating **	M	Issue No.	92
LM End	8.02	Issue Type +	Ma	Location *	WS
Category	Earthen Levee			GPS Latitude/Longitude	
				Start	End
Item	Slope Stability			38.409130 °	38.409130 °
				-121.539971 °	-121.539971 °
DWR ID	DWR_RD0150_03_s_2014_92				
Comment Code					
S1 : Repair slope instability.					
Inspector Comment

Updated picture of the slope instability on the waterside of the levee looking upstream during spring 2015 inspection.

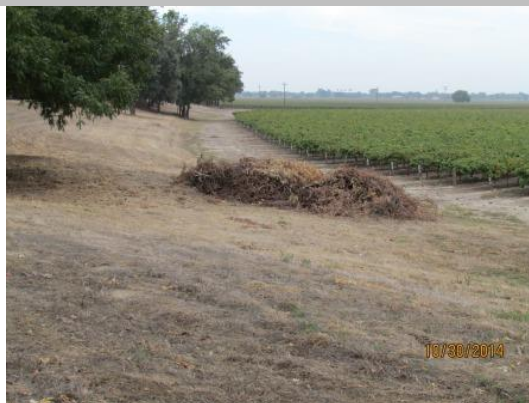
Photo 1 of 1 : SP_2017_RD0150_17_82_20170327_00062.jpg

LM Start	8.05	Rating **	M	Issue No.	82
LM End	8.05	Issue Type +	En	Location *	LS
Category	Earthen Levee			GPS Latitude/Longitude	
				Start	End
Item	Encroachments			38.409224 °	38.409224 °
				-121.539350 °	-121.539350 °
DWR ID	DWR_RD0150_03_f_2013_82				
Comment Code					
PR : Prunings					
Inspector Comment

Prunings were found on the landside toe of the levee looking upstream.

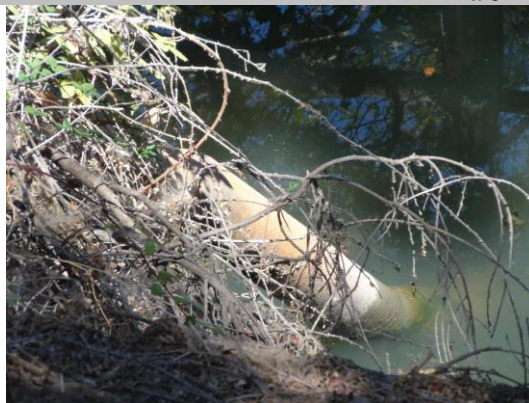
Photo 1 of 3 : UCIP_SP_2017_50670_33627.jpg

Comment Code						
Inspector Comment						
FS_ID:50670						
DS_ID:22466						
EP_NO: N/A						
Repair Type: Urgent						
Crossing Status: Found						
UCIP Comments: 07/08/2016: Needs proper abandonment. Levee caved in below pipe at gate valve on WS. Discussed abandonment with Warren Bogle of Colby Ranch. (K. Fazel - UCIP)08/23/2013: Needs proper abandonment (P. Amatya - DWR)						
FIELD_STRUCT_DESC: *ABANDONED* 10-inch steel irrigation pipe through the levee, 13.8 feet below the crown. Gate valve on the waterside (WS) slope. Pilings in water but no pump found. Service pole with guy wire on the landside (LS) slope. Standpipe on LS slope.						
[Additional Reference(s): DWR Levee Log, 2005. USACE Sacramento O&M Manual 112, March 1957 (HLM 8.34)].						
FS Date: 7/7/2016

WS view: pipe visible on levee slope and in the stream.

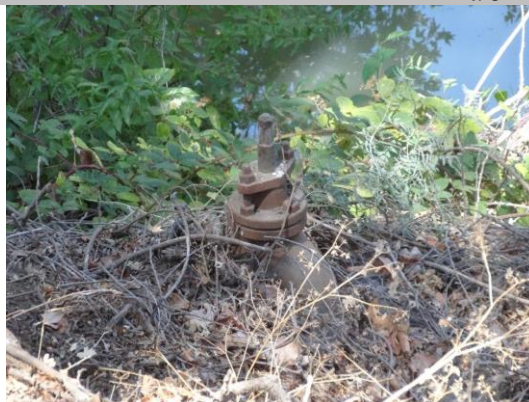
Photo 2 of 3 : UCIP_SP_2017_50670_33626.jpg

WS view: abandoned gate valve found on levee slope.

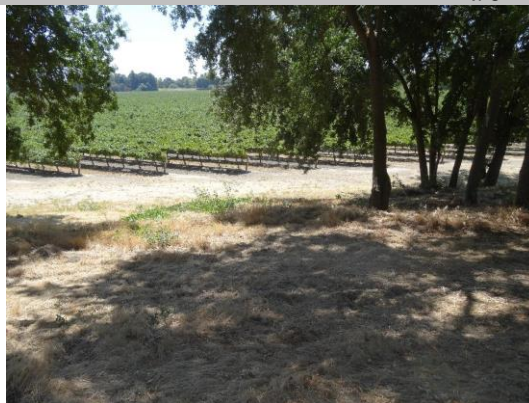
Photo 3 of 3 : UCIP_SP_2017_50670_33625.jpg

Comment Code					
Inspector Comment					
FS_ID:50670 DS_ID:22466 EP_NO: N/A Repair Type: Urgent Crossing Status: Found UCIP Comments: 07/08/2016: Needs proper abandonment. Levee caved in below pipe at gate valve on WS. Discussed abandonment with Warren Bogle of Colby Ranch. (K. Fazel - UCIP)08/23/2013: Needs proper abandonment (P. Amatya - DWR) FIELD_STRUCT_DESC: *ABANDONED* 10-inch steel irrigation pipe through the levee, 13.8 feet below the crown. Gate valve on the waterside (WS) slope. Pilings in water but no pump found. Service pole with guy wire on the landside (LS) slope. Standpipe on LS slope. [Additional Reference(s): DWR Levee Log, 2005. USACE Sacramento O&M Manual 112, March 1957 (HLM 8.34)]. FS Date: 7/7/2016

LS view: no pipe and structure found on landside.

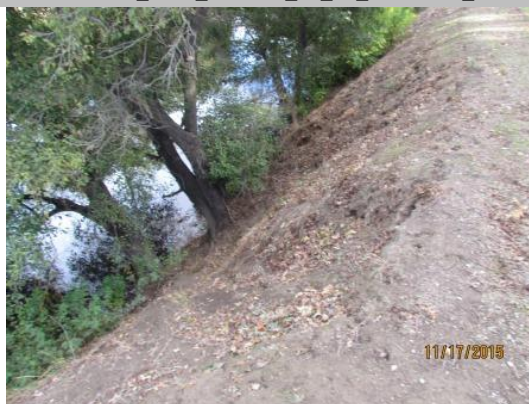
Photo 1 of 1 : SP_2017_RD0150_17_65_20170327_00046.jpg

LM Start	8.26	Rating **	M	Issue No.	65
LM End	8.26	Issue Type +	Ma	Location *	WS
Category	Earthen Levee			GPS Latitude/Longitude	
				Start	End
Item	Erosion / Bank Caving			38.408213 °	38.408213 °
				-121.535911 °	-121.535911 °
DWR ID	DWR_RD0150_03_f_2015_65				
Comment Code					
E1 : Note and monitor erosion site.					
Inspector Comment

View of erosion on the waterside of the levee.

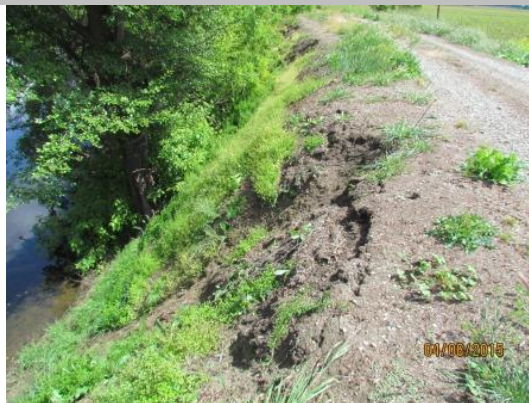
Photo 1 of 1 : SP_2017_RD0150_17_66_20170327_00047.jpg

LM Start	8.31	Rating **	M	Issue No.	66
LM End	8.31	Issue Type +	Ma	Location *	WS
Category	Earthen Levee			GPS Latitude/Longitude	
				Start	End
Item	Erosion / Bank Caving			38.407960 °	38.407960 °
				-121.534898 °	-121.534898 °
DWR ID	DWR_RD0150_03_s_2012_66				
Comment Code					
E2 : Schedule repair of erosion site prior to the next inspection.					
Inspector Comment

Updated picture of the erosion on the waterside of the levee.

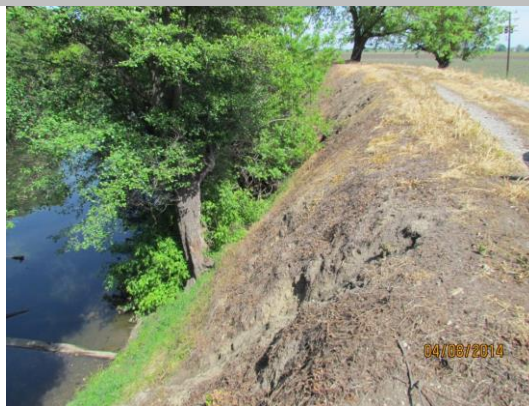
Photo 1 of 2 : SP_2017_RD0150_17_67_20170327_00048.jpg

LM Start	8.33	Rating **	M	Issue No.	67
LM End	8.33	Issue Type +	Ma	Location *	WS
Category	Earthen Levee			GPS Latitude/Longitude	
				Start	End
Item	Erosion / Bank Caving			38.407958 °	38.407958 °
				-121.534583 °	-121.534583 °
DWR ID	DWR_RD0150_03_s_2012_67				
Comment Code					
E1 : Note and monitor erosion site.					
Inspector Comment

Updated picture of the erosion on the waterside shoulder looking upstream during spring 2014 inspection.

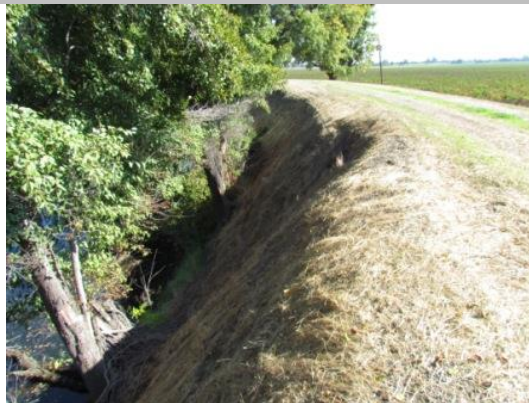
Photo 2 of 2 : SP_2017_RD0150_17_67_20170327_00049.jpg

Erosion was found on the waterside shoulder of the levee looking upstream. This picture was taken during fall 2012 inspection.

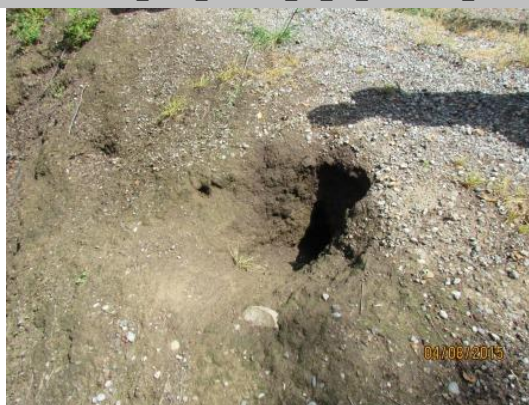
Photo 1 of 2 : SP_2017_RD0150_17_89_20170327_00067.jpg

LM Start	8.37	Rating **	U	Issue No.	89
LM End	8.37	Issue Type +	Ma	Location *	WS
Category	Earthen Levee			GPS Latitude/Longitude	
				Start	End
Item	Animal Control			38.408153 °	38.408153 °
				-121.533980 °	-121.533980 °
DWR ID	DWR_RD0150_03_s_2012_89				
Comment Code					
A1 : Exterminate rodents and backfill and compact or grout burrows.					
Inspector Comment

Updated picture of a rodent hole on the waterside shoulder of the levee during spring 2015 inspection.

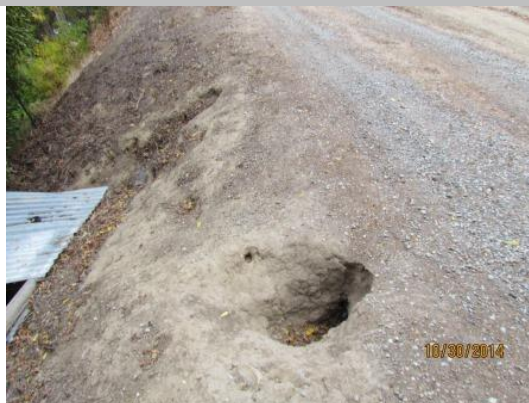
Photo 2 of 2 : SP_2017_RD0150_17_89_20170327_00068.jpg

Updated picture of a rodent hole on the waterside shoulder of the levee during fall 2014 inspection.

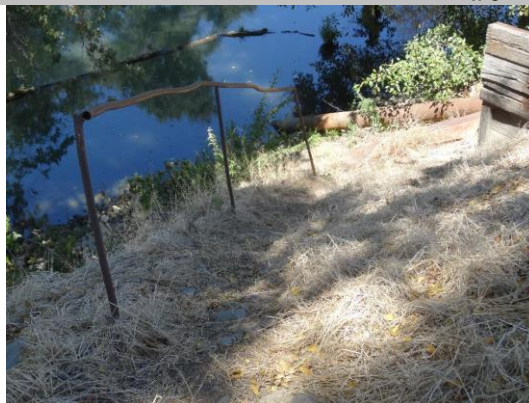
Photo 1 of 3 : UCIP_SP_2017_41648_33642.jpg

LM Start	8.37	Rating **	M	Issue No.	964
LM End	8.37	Issue Type +	En	Location *	WS
Category	Supplemental			GPS Latitude/Longitude	
				Start	End
Item	DWR UCIP Field Study			38.408188 °	38.408188 °
				-121.533935 °	-121.533935 °
DWR ID					
Comment Code					
Inspector Comment					
FS_ID:41648					
DS_ID:22467					
EP_NO: N/A					
Repair Type: Non-Urgent					
Crossing Status: Found					
UCIP Comments: - walkway in poor functional condition- an abandoned 8-inch steel pipe next to 12" pipe. This 8" pipe might have merged with 12" pipe under the levee .- Pipe and pump inside concrete masonry wall.					
FIELD_STRUCT_DESC: 12-inch steel pipe through the levee, 13.0 feet below the crown, pump and gate valve in pump house on the waterward slope. Concrete distribution box at the landward toe. Service pole on the waterward shoulder. O&M Manual SAC 112, March 1957.					
FS Date: 8/23/2013

WS view: walkway and inlet pipe on levee slope.

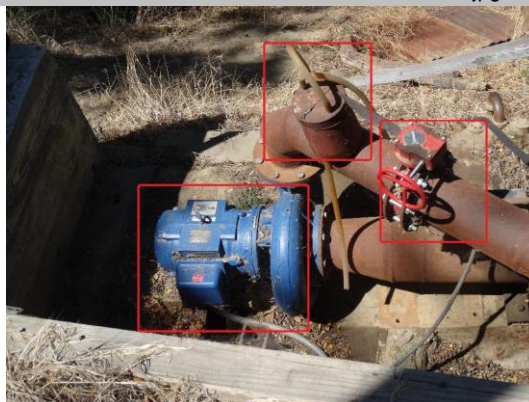
Photo 2 of 3 : UCIP_SP_2017_41648_33641.jpg

WS view: pump, gate valve, and airvent on pipe inside concrete masonry box.

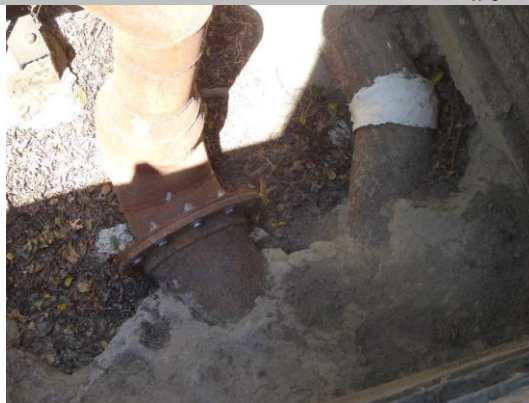
Photo 3 of 3 : UCIP_SP_2017_41648_33640.jpg

Comment Code					
Inspector Comment					
FS_ID:41648					
DS_ID:22467					
EP_NO: N/A					
Repair Type: Non-Urgent					
Crossing Status: Found					
UCIP Comments: - walkway in poor functional condition- an abandoned 8-inch steel pipe next to 12" pipe. This 8" pipe might have merged with 12" pipe under the levee .- Pipe and pump inside concrete masonry wall.					
FIELD_STRUCT_DESC: 12-inch steel pipe through the levee, 13.0 feet below the crown, pump and gate valve in pump house on the waterward slope. Concrete distribution box at the landward toe. Service pole on the waterward shoulder. O&M Manual SAC 112, March 1957.					
FS Date: 8/23/2013

WS view: 8-inch steel pipe (right) next to 12" pipe (left). This 8" pipe might have merged with 12" pipe under the levee .

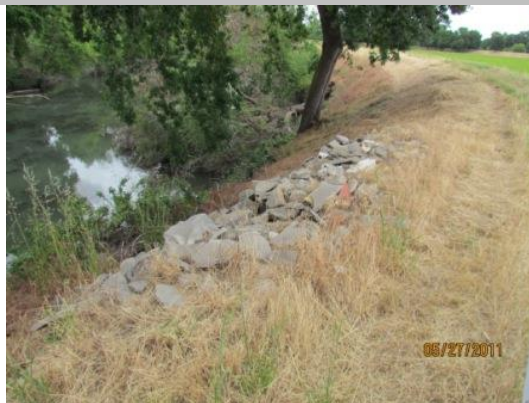
Photo 1 of 1 : SP_2017_RD0150_17_7_20170327_00002.jpg

LM Start	8.72	Rating **	M	Issue No.	7
LM End	8.72	Issue Type +	En	Location *	WS
Category	Earthen Levee			GPS Latitude/Longitude	
				Start	End
Item	Encroachments			38.411593 °	38.411593 °
				-121.529143 °	-121.529143 °
DWR ID	DWR_RD0150_03_s_2012_7				
Comment Code					
DE : Debris					
Inspector Comment

Broken concrete pipe was left on the waterside slope of the levee. The picture was taken from the crown looking upstream.

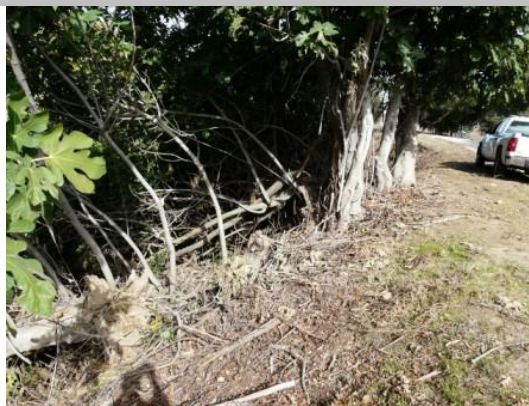
Photo 1 of 1 : SP_2017_RD0150_17_73_20170327_00053.jpg

LM Start	9.35	Rating **	U	Issue No.	73
LM End	9.35	Issue Type +	Ma	Location *	WS
Category	Earthen Levee			GPS Latitude/Longitude	
				Start	End
Item	Trim / Thin Trees			38.413169 °	38.413169 °
				-121.523707 °	-121.523707 °
DWR ID	DWR_RD0150_03_s_2012_73				
Comment Code					
T3 : Trim and thin trees to allow visibility of the ground and room to flood fight.					
Inspector Comment

Thin/trim trees to allow for visibility of top 20' of waterward slope.

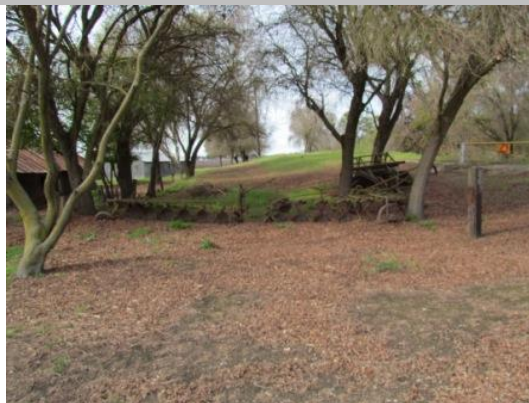
Photo 1 of 1 : SP_2017_RD0150_17_950_20170327_00091.jpg

LM Start	9.39	Rating **	M	Issue No.	950
LM End	9.39	Issue Type +	En	Location *	LS
Category	Earthen Levee			GPS Latitude/Longitude	
				Start	End
Item	Encroachments			38.413560 °	38.413560 °
				-121.522936 °	-121.522936 °
DWR ID	DWR_RD0150_03_s_2012_950				
Comment Code					
EQ : Equipment					
Inspector Comment

Equipment was found on the landside of the levee looking downstream.
